Richmond Refinery LPS Bulletin – Reliability

Seal Failure When Spare was Unavailable

Hydroprocessing – 18 Plant
- P-1831 sour NH₃ Pumps

Investigation #148550

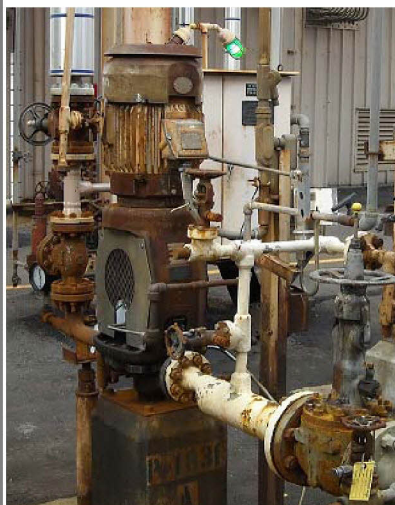
Photo of P-1831A as installed in the field..

P-1831A (spare for P-1831) had been put in service and ran 7 days when it was discovered that the seal was excessively leaking on the morning of 2/25/12. It was then determined by operations to shutdown the pump as it could not continue to run reliably due to the leak. P-1831A was shutdown and isolated, and due to the fact that both pumps were out of service, the plant had to be shutdown. Repairs were made and P-1831 was returned to service within 2 days.

Subsequently, a second seal failure occurred on this pump on 6/22/12 resulting in a clock reset. This failure was of the same mode as identified from the previous investigation.

- 1) In 1984 the seal design for these pumps was changed from a dual pressurized seal (API plan 53A) to a single seal with a process flush and a water flush (API plan 11 and 23) – no information on the reason for this change could be located.
- 2) The new seal design requires both flush streams running to keep product from flashing across the seal faces and causing them to leak – however, the water flush contaminates the product and is routinely shutoff by operations to protect the process.
- 3) Pumps were not resized during the TURBO project at RLOP in 2007 - The pump cavitates often, especially during startup, which is known to contribute to seal failures.
- 4) Although there is a history of high seal failure rates on the P-1831 pumps at 18 Plant, past investigations had not found the root causes of the failures.

- 1) Run a hydraulic analysis for the P-1831's to identify the root cause of cavitations during start-up. Use the results to determine if the pumps are oversized.
- 2) Investigate seal flush system to determine if system is adequate for plant operation.
- 3) Change to dual pressurized seals on P-1831 and P-1831A with API Plan 53A Flush. Upgrade to API 682 seal if available to fit this pump.
- 4) Use the MOC process to facilitate reviews and keep records of changes associated with seal modifications.
